Manhole Inspection Summary

Manhole # S11II1025MH

Insp Date: **5/25/07 9:09 AM**

Location Address: **2807 RIDGEWOOD AVE**

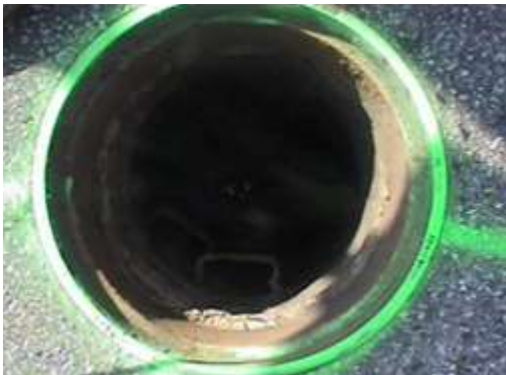
Defect 2

Offset: **1** (in.)

FRAME OFFSET

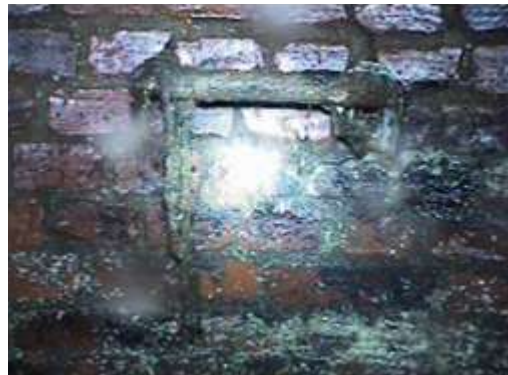
Defect 1

Count: **10** Missing: **0** ☒ **Corroded**

☒ **Evidence Of Surcharge** Depth: **7** (ft.) ☐ Active Surcharge Present

EVIDENCE OF SURCHARGE AND
CORRODED STEP

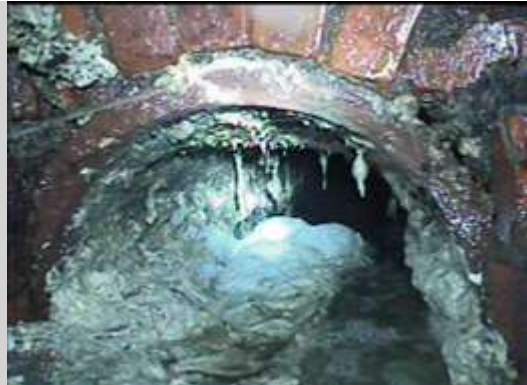
12 O'Clock Outflow

15 in. Circular Gravity Sewer
Pipe Out @ 12 O'Clock

Pipe Height: **15.6** (in.) Rod and Bar (Angled)
Pipe Material: **Clay** ☐ Pipe Lined
Invert Depth: **15.86** (ft.) Flow Characteristics: **Fast**
Deposits: ☐ None ☒ Mud ☒ ~~Sludge~~ ☒ Debris ☒ Grease
Silt Depth: **5** (in.) Deposits Extent: **Heavy**
Infiltration: **None** Pipe Seal Cond: **Cracked**

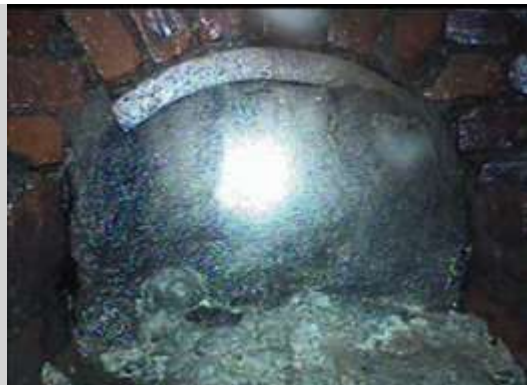
3 O'Clock Inflow

15 in. Circular Gravity Sewer
Pipe In @ 3 O'Clock

Pipe Height: (in.) Direct
Pipe Material: **Unknown** ☐ Pipe Lined
Invert Depth: **14.77** (ft.) Flow Characteristics: **None**
Deposits: ☒ None ☐ Mud ☐ ~~Sludge~~ ☐ Debris ☐ Grease
Silt Depth: (in.) Deposits Extent:
Infiltration: **None** Pipe Seal Cond: **Sound**

Connects To: **Stub connection / abandoned**

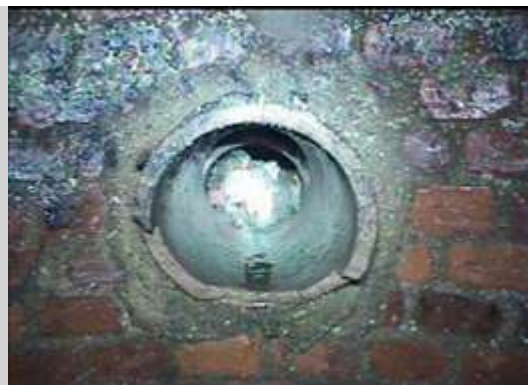
9 O'Clock Inflow

8 in. Circular Gravity Sewer

Pipe In @ 9 O'Clock

Deposits: ☐ None ☐ Mud ☒ **Sludge** ☒ **Debris** ☒ **Grease**

Silt Depth: **3** (in.) Deposits Extent: **Medium**

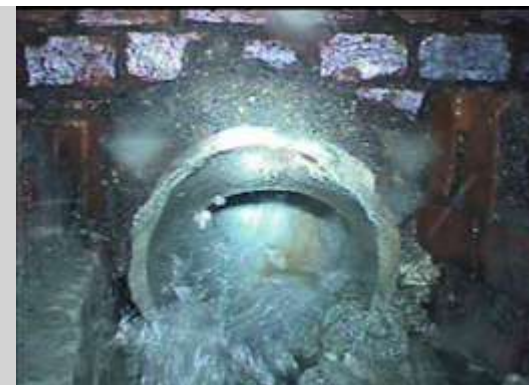
Drop In @ 9 O'Clock

Drop: **Outside** Rod and Bar

Angled: **Yes** Reading: **14.64** (ft.)

Inv Depth: **15.64** (ft.)

Drop Condition: **Open**
